# Emerson Network Power Data Center Assessment Report of Findings

Customer A

Data Center Assessment

1243 Happy Days Lane  
Somewhere, MN 55555

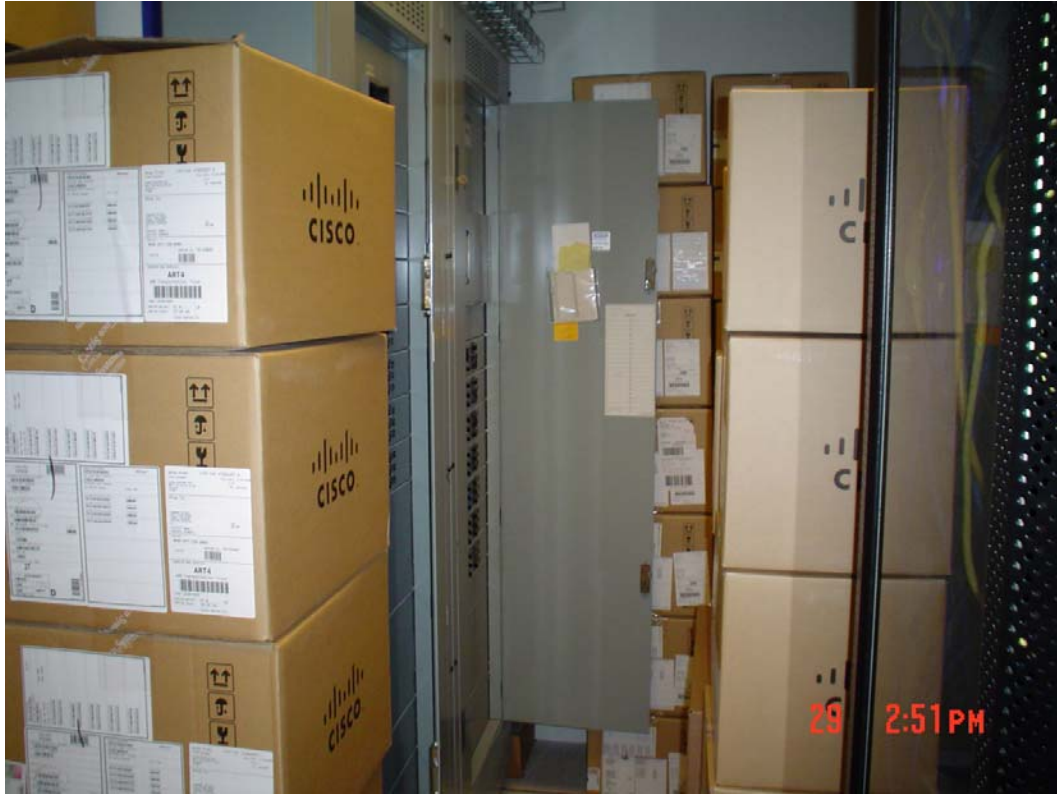
- 5) The ULP-D-1A, -1B and -1C panelboards in the computer room were found with stacks of boxes stored in front of the three panelboards. The National Electrical Code article 110.32 states “Work Space about Equipment. Sufficient space shall be provided and maintained about electrical equipment to permit ready and safe operation and maintenance of such equipment. Where energized parts are exposed, the minimum clear work space shall be not less than 2.0 m (6 1/2 ft) high (measured vertically from the floor or platform) or not less than 914 mm (3 ft) wide (measured parallel to the equipment). The depth shall be as required in 110.34(A). In all cases, the work space shall permit at least a 90 degree opening of doors or hinged panels.” The boxes must be stored in a designated storage area away from electrical equipment.

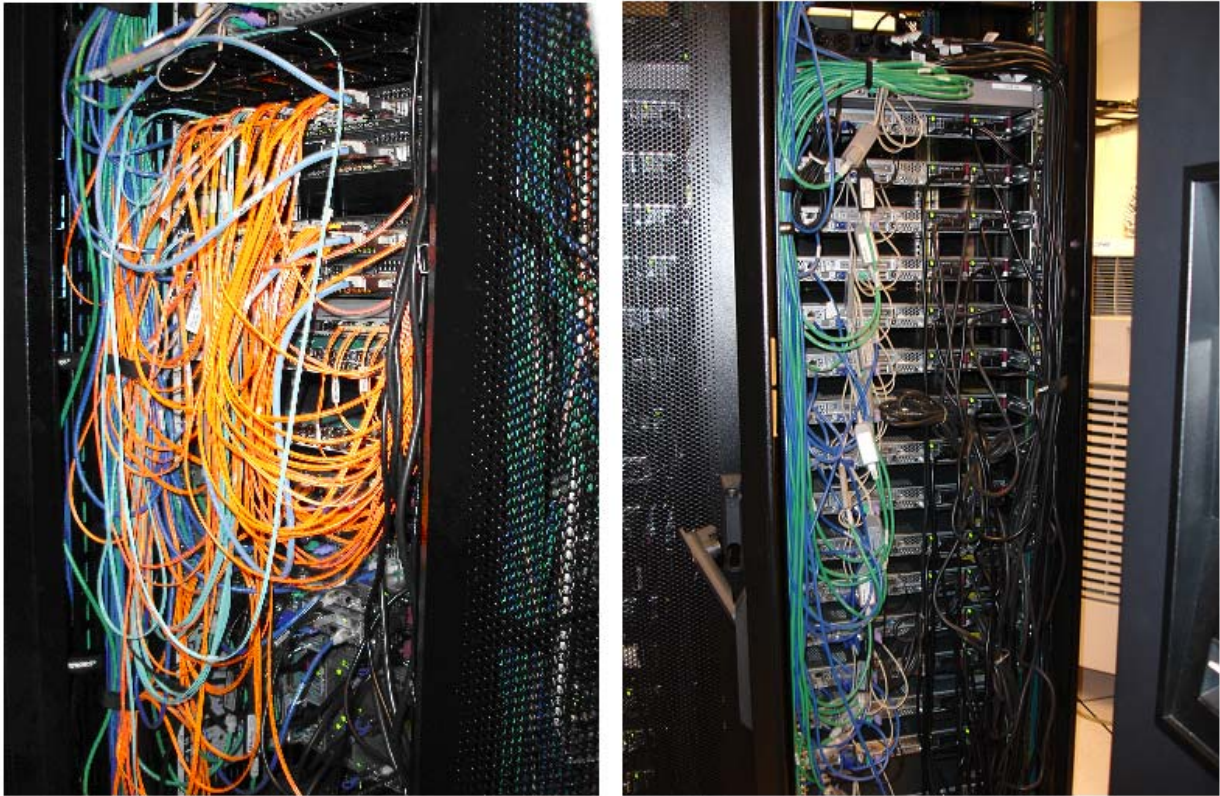
Various computer rack manufacturers were employed in the data center. Most racks had doors on their inlet and exhaust sides. Those that did had fully perforated exhaust doors and glass panel inlet doors with a perforated border for airflow. The width between rows was between 2-1/2 and 3 feet. Many of the racks did not contain side panels or blanking plates for empty U slots. This can lead to short circuiting which is when exhaust air from a server is pulled into the inlet of another server in a neighboring rack before it is cycled back through a CRAC unit. This leads to higher server temperatures and possible failure of equipment. Also, some racks had wires resting over a large portion of the exhaust side of the servers. Wiring can act as an air obstruction which reduces airflow through the servers and holds unwanted heat near the racks. This can dramatically raise server temperatures. Wiring that serves rack computer equipment should be kept to a minimal length and organized along the sides of the rack to avoid obstructing hot exhaust airflow. Examples of this seen in the data center are shown on next page.

Figure 2.1.1 – Dense Cabling Restricting Server Air Flow

5. Organize all cabling at exhaust side of racks to the sides of the servers, thus enabling unrestricted flow of exhaust air.
6. Seal off the Data Center from other areas to maintain a vapor/temperature barrier so fluctuations in environmental conditions are eliminated.

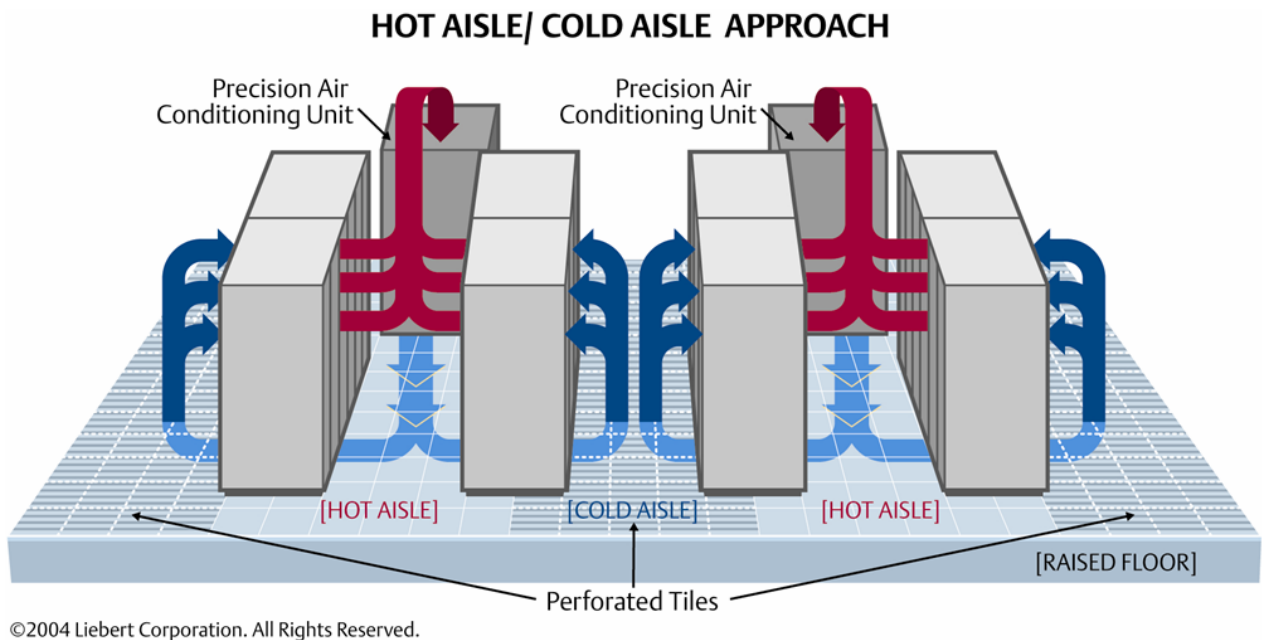
Figure 2.1.2 – Diagram of a True Hot/Cold Aisle Configuration

One of the most important things shown in this diagram is the location of the CRAC units at the end of the hot aisles. By having the CRAC units located here, the exhaust air can rise freely to the level of the CRAC unit's intakes while not being pulled into the intakes of the computer equipment. As most racks in the data center have room for additional equipment, there is the potential for higher heat loads being incorporated into the data center. As more computer equipment is added to this area or new, faster, and higher watt density equipment replaces existing equipment, higher rack temperatures are to be expected if changes to the availability of airflow are not made. This availability could be in the form of changes to the current airflow configuration or additions of more or newer cooling means.

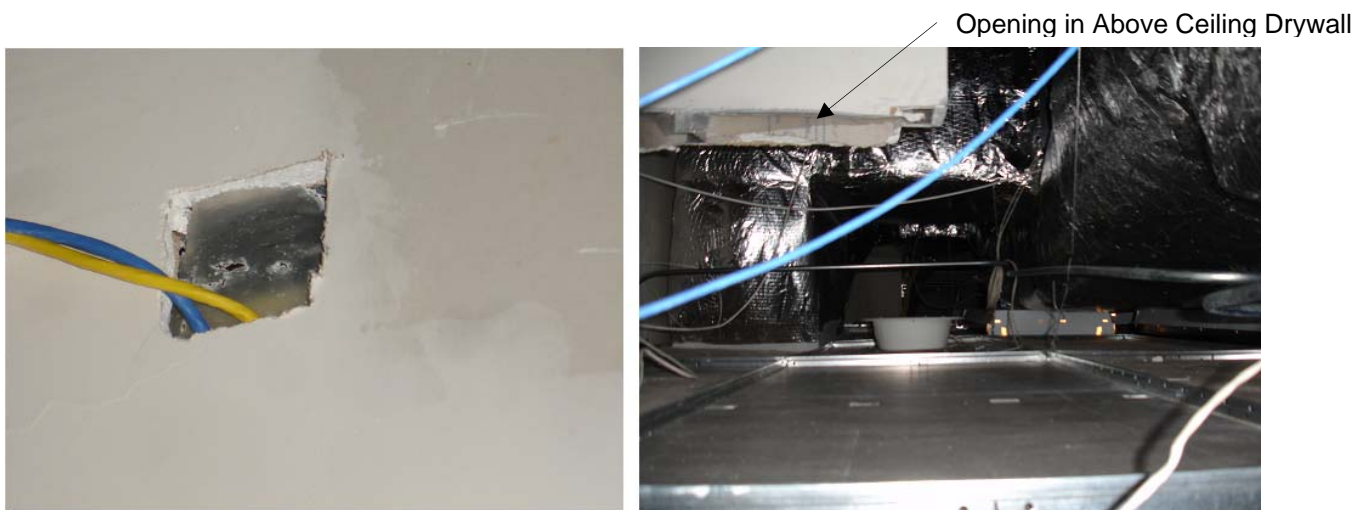
There were some issues with vapor barrier integrity within the above ceiling plenum. Any hole or unsealed penetration in the wall is a path for air to enter the data center from neighboring areas. This unwanted air does not have temperature and humidity controls that meet the demands of data center conditions. Examples found in the above ceiling plenum have been recorded and are shown below.

Figure 2.1.3 – Wall Penetrations in Above Ceiling Plenum

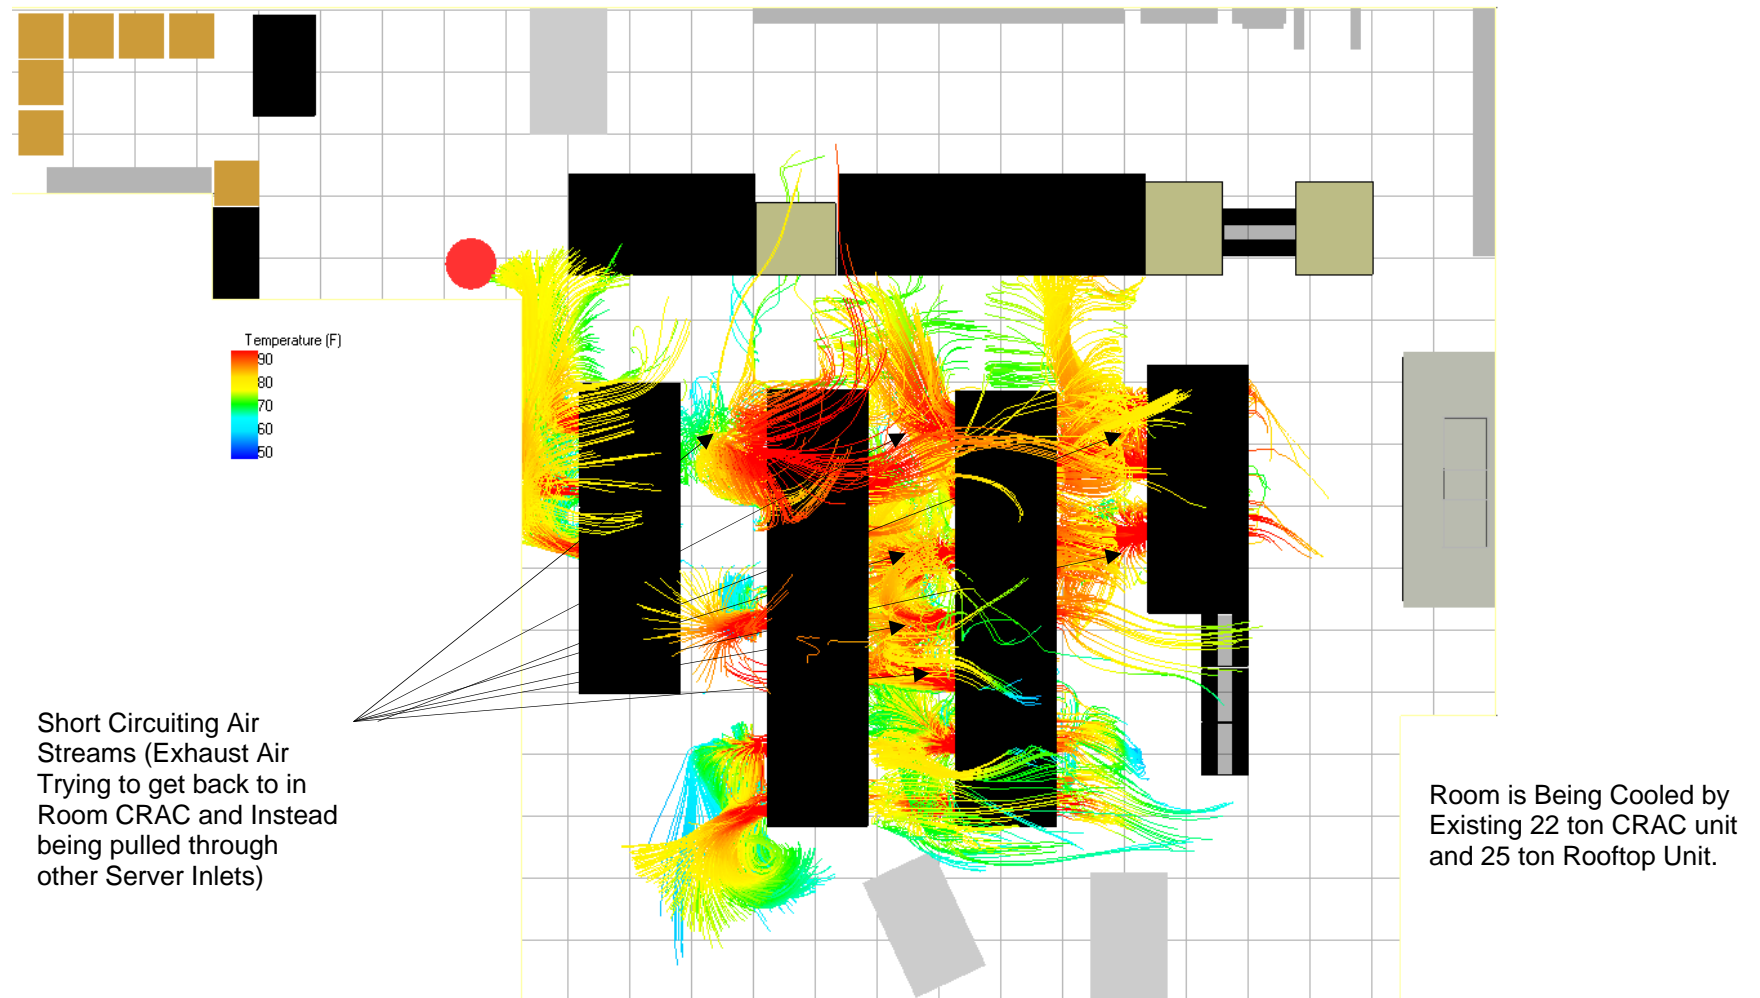
Figure 2.2.3 – Simulated Server Exhaust Airflow

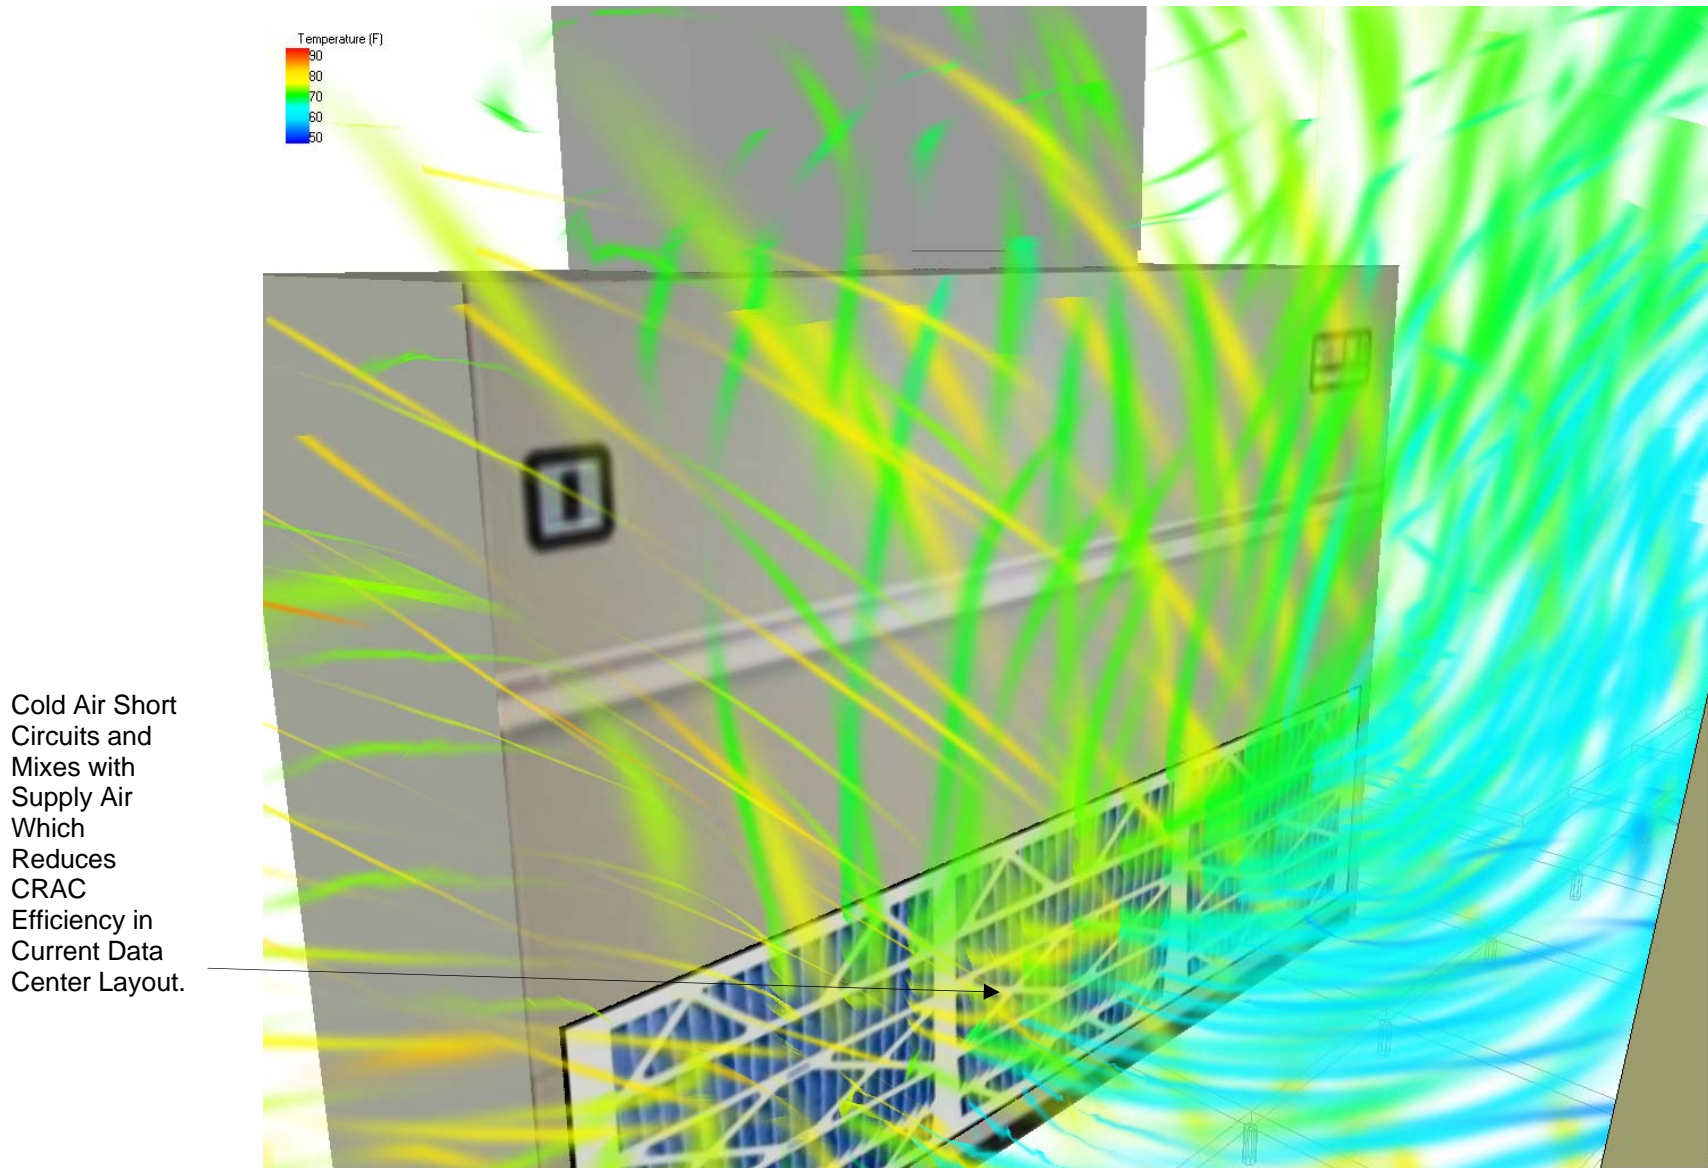
Figure 2.2.4 – Simulated Return CRAC Air

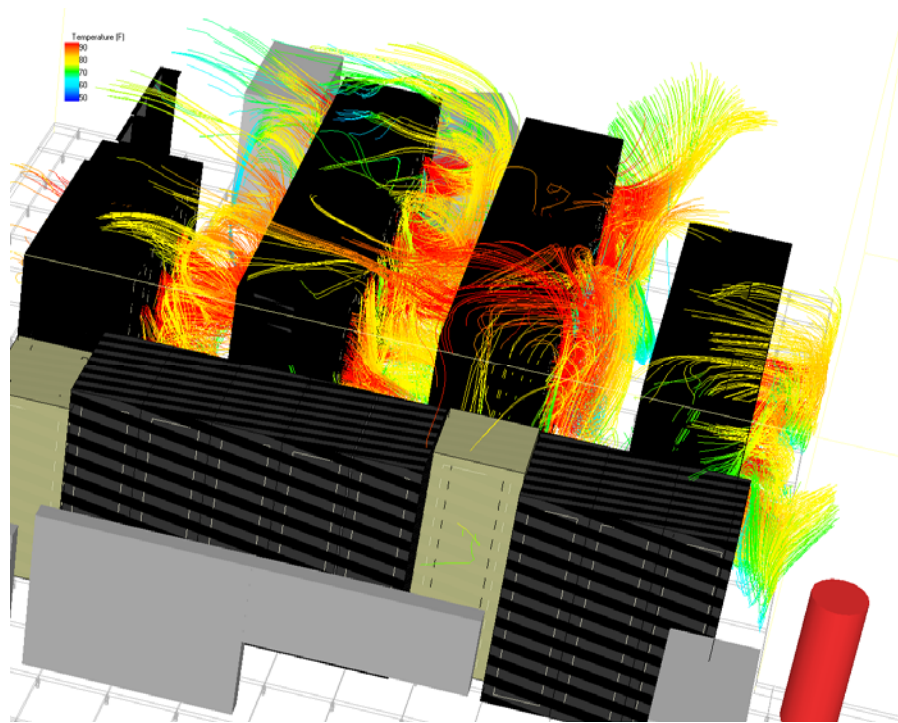
The Any Data Center did not follow a hot/cold aisle configuration. All of the rack exhausts faced neighboring rack inlets. This prohibits hot air from effectively returning to the cooling units and more importantly allows short circuiting of warmer air back into the rack inlets in the same area. In the current layout, air is being pulled through up to four rows of racks before it is ever returned to the CRAC unit! When the exhaust from one rack becomes the intake air for another, problems arise very quickly. Another cause of short circuiting air is the narrow aisles between racks. A significant amount of air is being forced through these areas from both CRAC supply as well as the fans in the servers to meet the demand of the heat load. When there is limited area for this to happen, high generalized air velocities occur which creates low pressures. As a result, exhaust air from other areas of the room is forced into the aisle often replacing the much needed cold supply air. The recommended aisle width is 4 ft. A simulated illustration of this can be seen below where air is moving both straight through series of racks as well as back over the tops of racks to the same inlet areas.

Figure 2.3.1 – Short Circuiting Exhaust Air

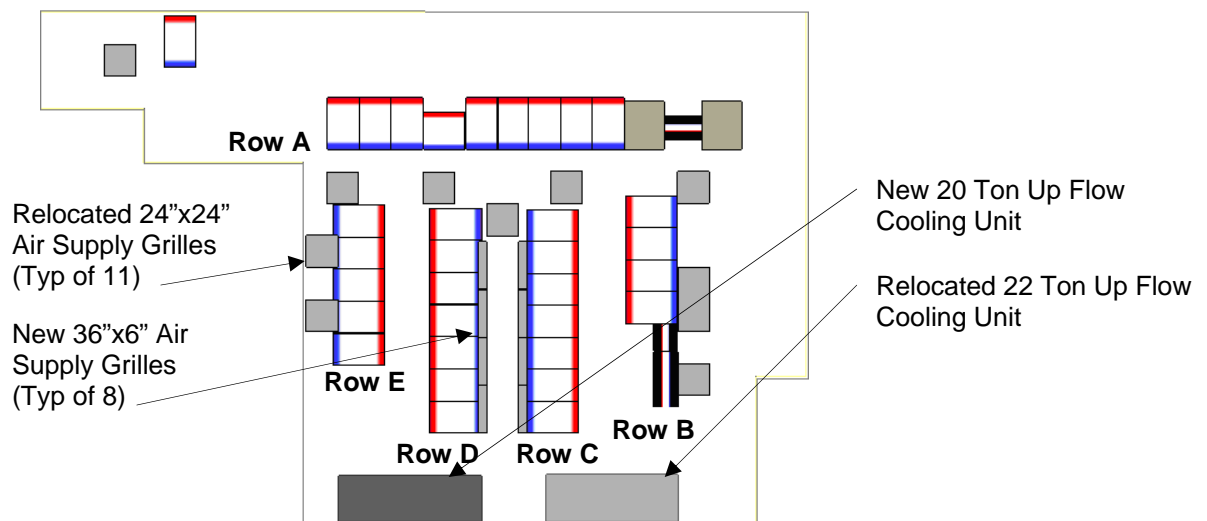
The addition of only one CRAC unit has obvious advantages financially. If enthalpy and low ambient control can be added to the rooftop system, it can be used as the redundant cooling source for the data center. The existing CRAC unit can then be moved to the adjacent wall (as shown below) and work in combination with the new 20 ton unit. The above ceiling ductwork will need to be slightly reworked to accommodate the changes.

Figure 3.1.1 – Solution 1 Plan

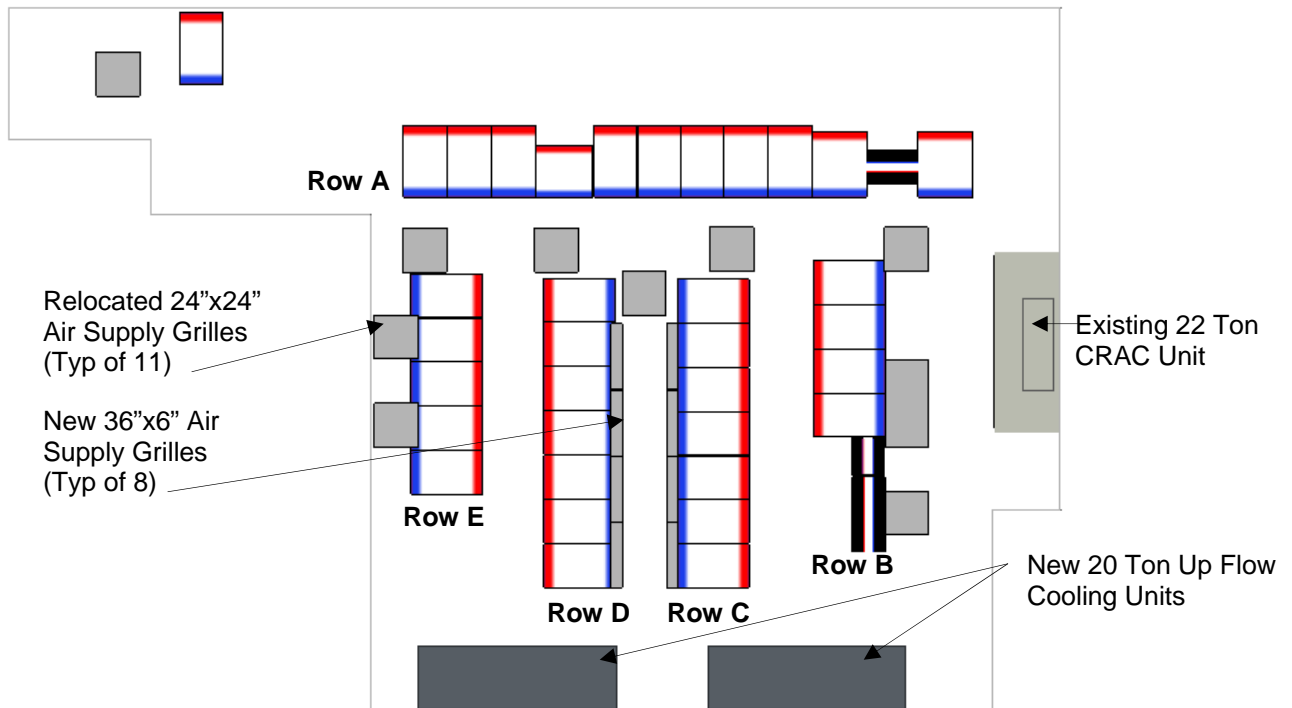
There are many difficulties associated with renovating a data center while it is in operation. There are two major considerations that would result in Solution 2 being the best plan of action. First, if it is not desired to move the existing CRAC unit, the two additional units can be added and ducted into the existing ductwork with some reworking required. Also, if enthalpy and low ambient control is not available for the rooftop system, the rooftop unit will not be recommended for use as it can't provide reliable redundancy. This will require the two new units specified to ensure N+1 redundancy.

Figure 3.1.2 – Solution 2 Plan

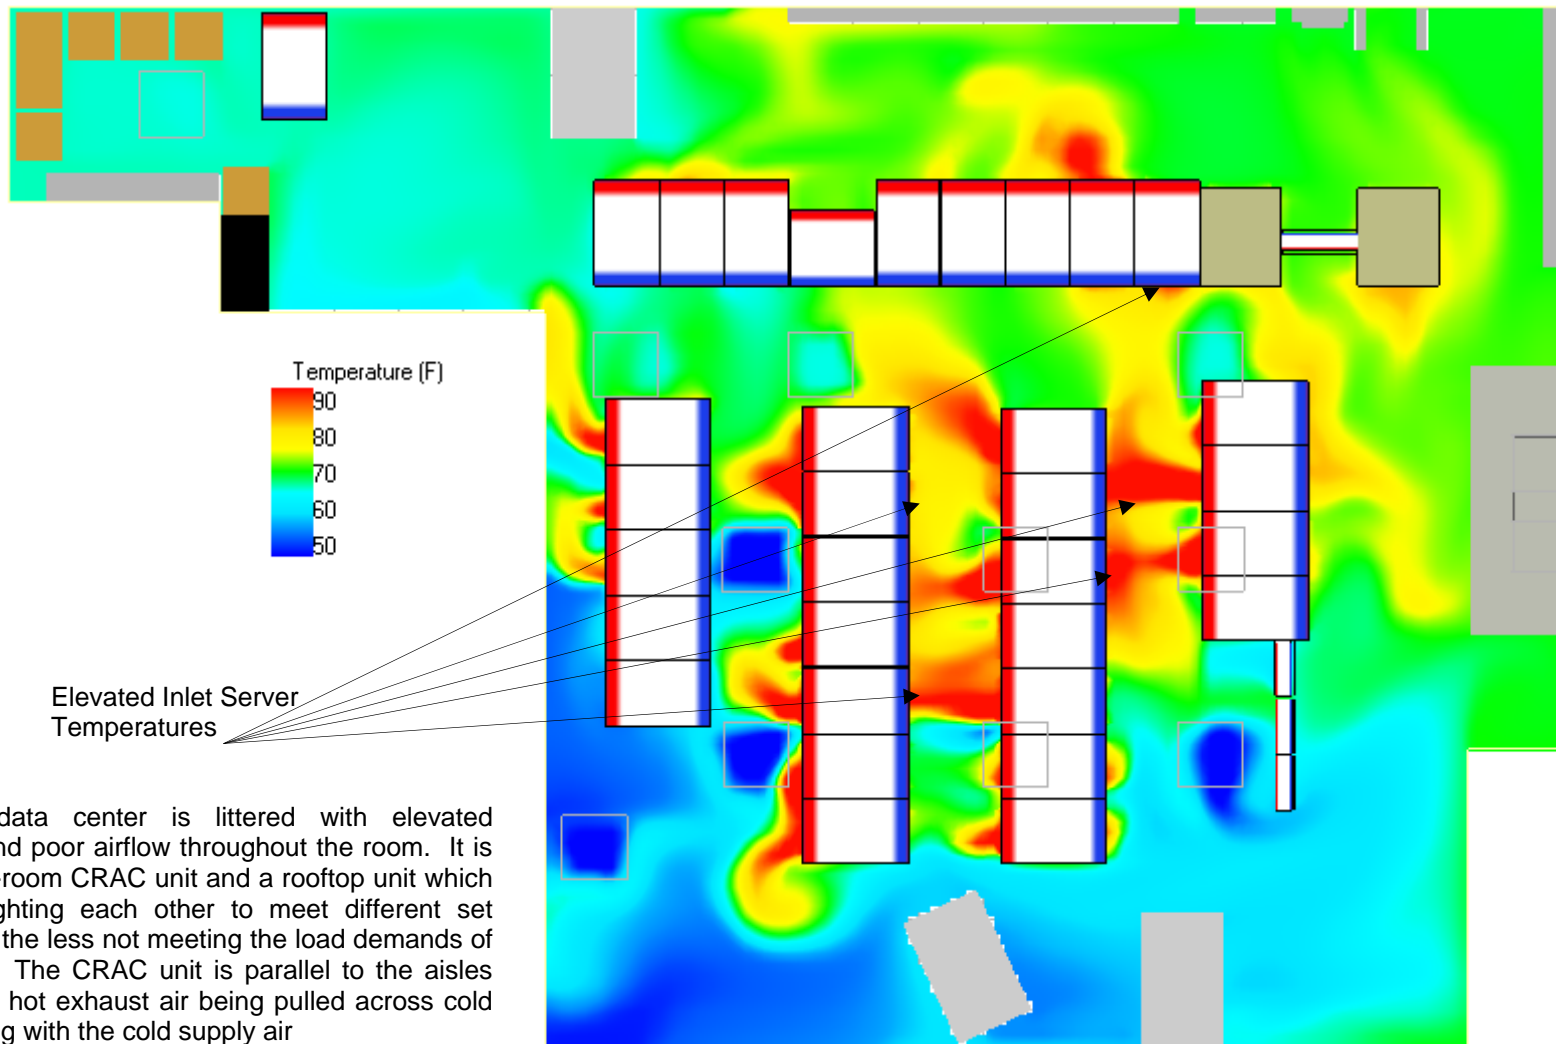
Figure 3.1.3 – As-Is Worst Case Temperatures (6ft.)

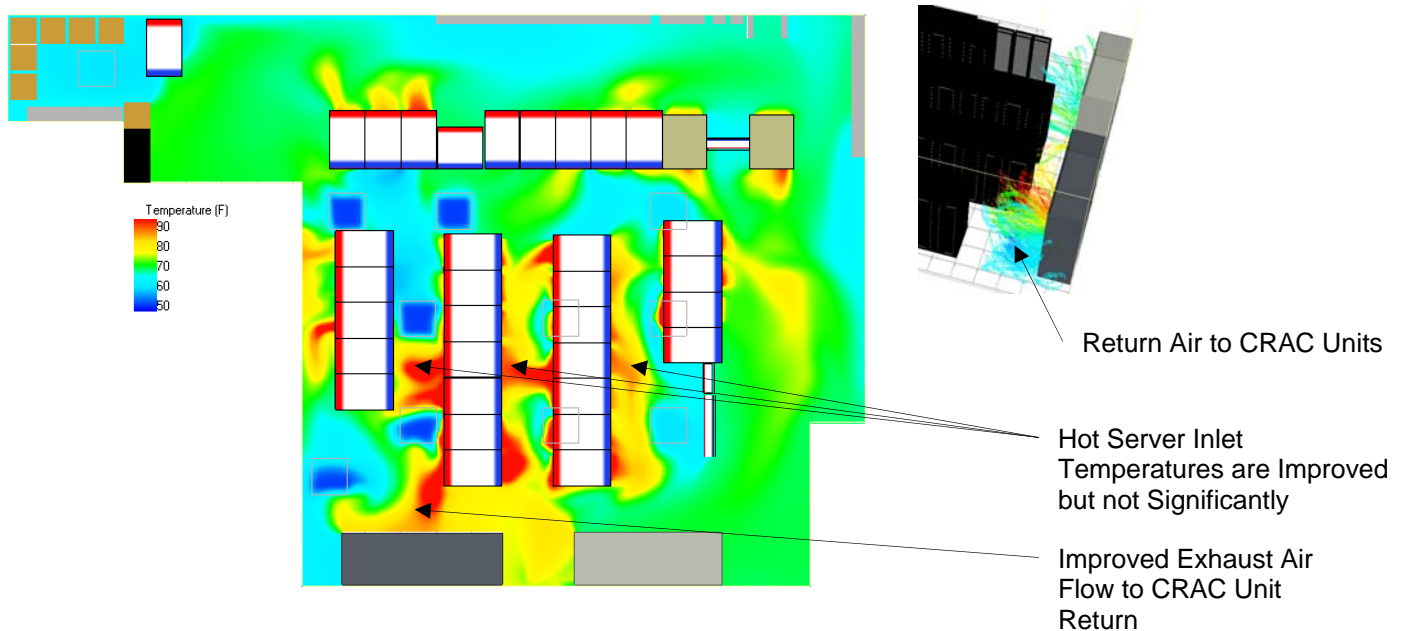
Figure 3.1.4a – Solution 1 – Without Blank Plates (6ft.)

Placing two CRAC units at the end of the rack aisles improves air flow efficiency and reduces hot air mixing with cold supply air. Due to the rack configuration though, there is still an abundance of short circuiting air present.

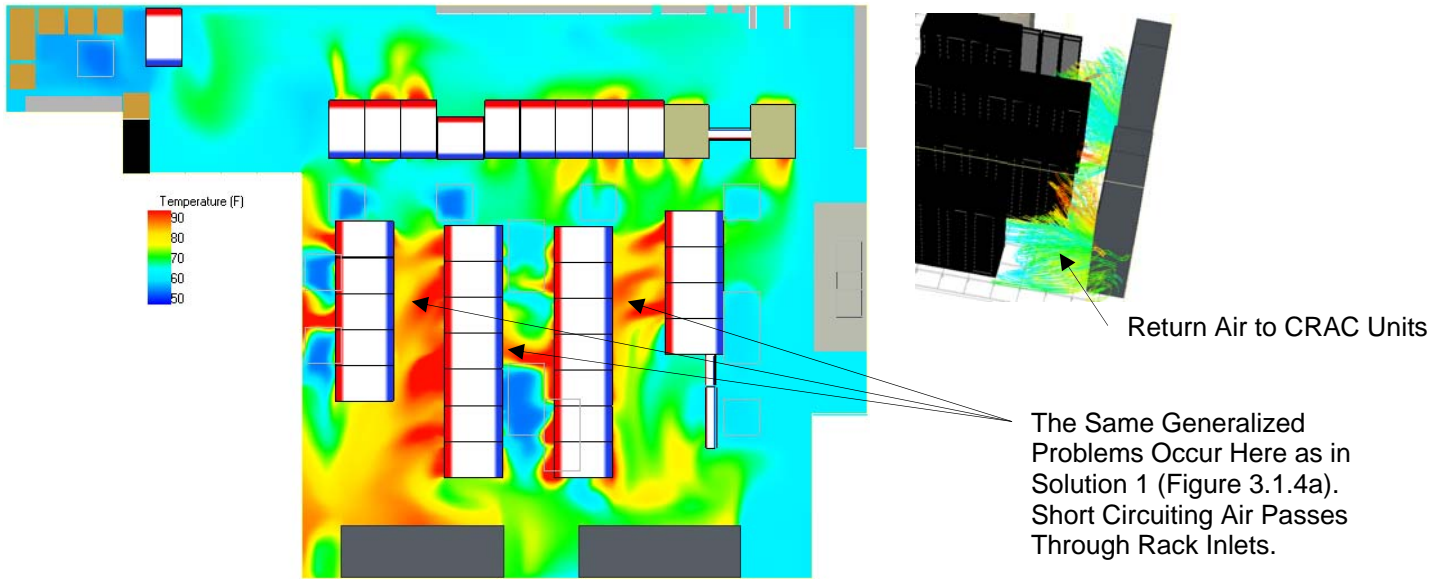
Figure 3.1.5a – Solution 2 – Without Blank Plates (6ft.)

Placing two CRAC units at the end of the rack aisles improves air flow efficiency and reduces hot air mixing with cold supply air. Due to the rack configuration though, there is still an abundance of short circuiting air present.

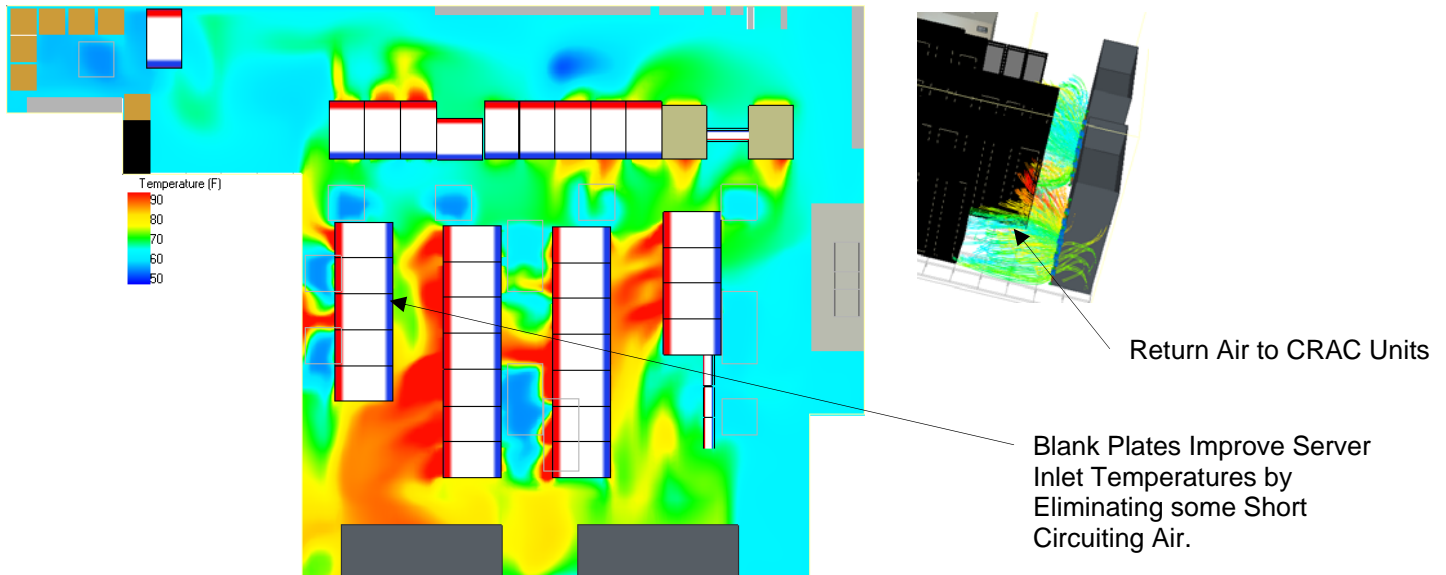
The addition of blank plates helps eliminate localized short circuiting which is caused by server inlets pulling exhaust air through open space in the rack. This happens when the quantity of air on the inlet side is not satisfying the needs of the servers. With blank plates installed, the hot exhaust air is unable to be pulled back through the rack which allows for cooler air from other areas of the room to be pulled in.

Figure 3.1.5b – Solution 2 – Blank Plates Added (6 ft.)

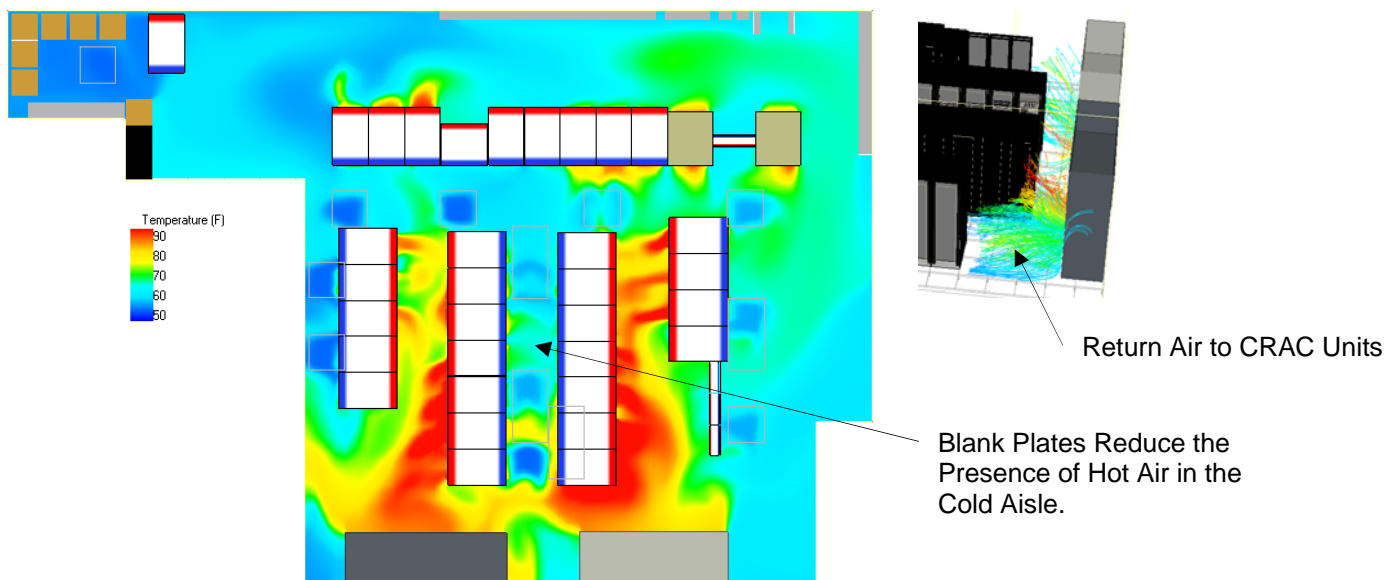
Figure 3.1.6a – Solution 1 – Hot/Cold Aisle w/out Blank Plates (6ft.)

Reconfiguring the rack layout to a hot/cold aisle arrangement provides immense improvements to data center efficiency. The hot exhaust air is isolated away from server inlets much more efficiently, especially with blank plates installed on all empty U slots. In this layout, air supply grilles can be relocated to provide cold air only where it is needed.

Figure 3.1.6b – Solution 1 – Hot/Cold Aisle w/Blank Plates (6ft.)

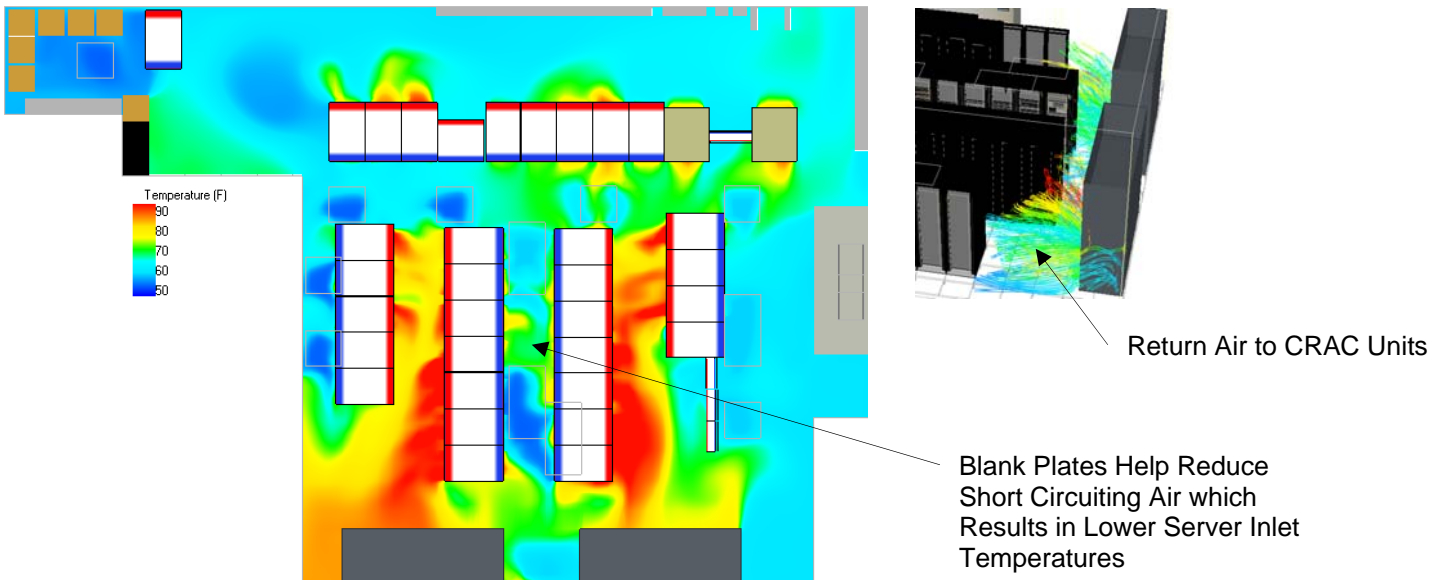
Figure 3.1.7a – Solution 2 – Hot/Cold Aisle w/out Blank Plates (6ft.)

Reconfiguring the rack layout to a hot/cold aisle arrangement provides immense improvements to data center efficiency. The hot exhaust air is isolated away from server inlets much more efficiently, especially with blank plates installed on all empty U slots. In this layout, air supply grilles can be relocated to provide cold air only where it is needed.

Figure 3.1.7b – Solution 2 – Hot/Cold Aisle w/Blank Plates (6ft.)

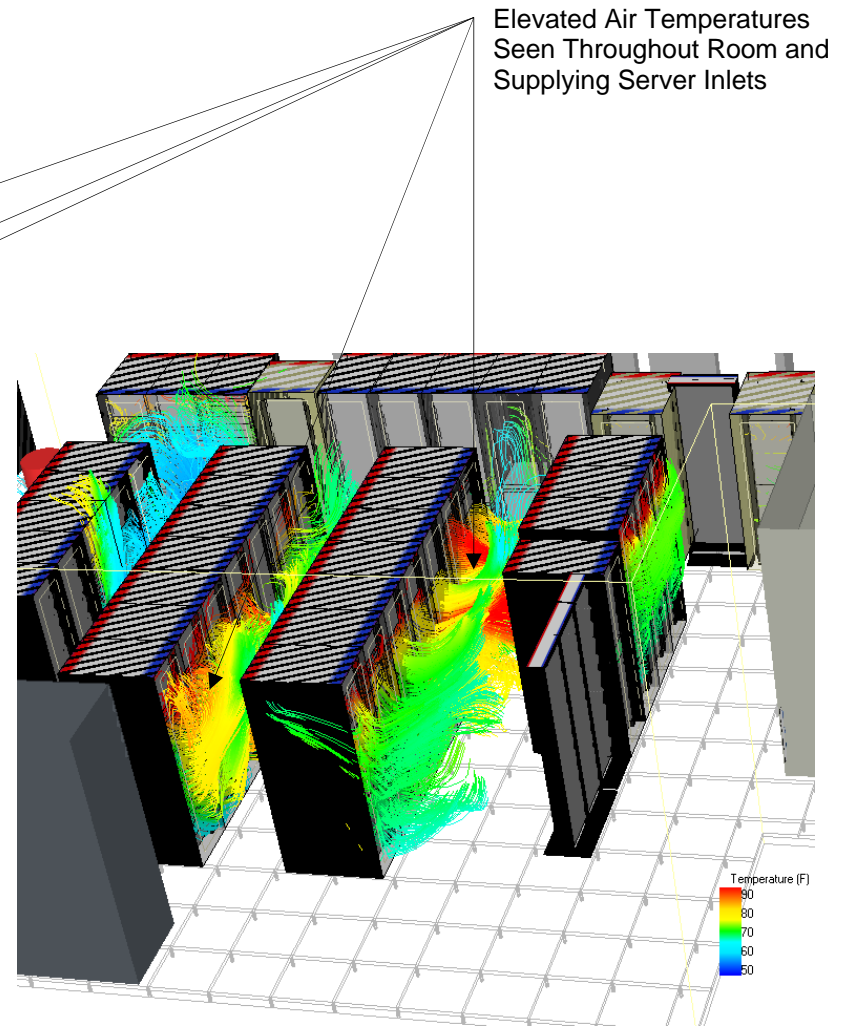
Simply adding more cooling to the room is not the answer for the problems in this data center. The changes previously discussed in this section must be completed to see a real improvement in the data center cooling and server well being.

Figure 3.1.10 – Data Center with the Addition of a Second CRAC Unit Only

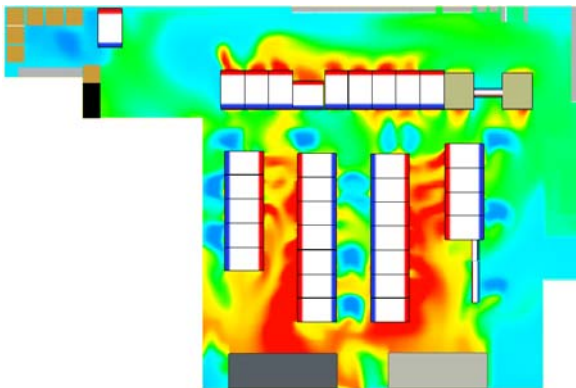
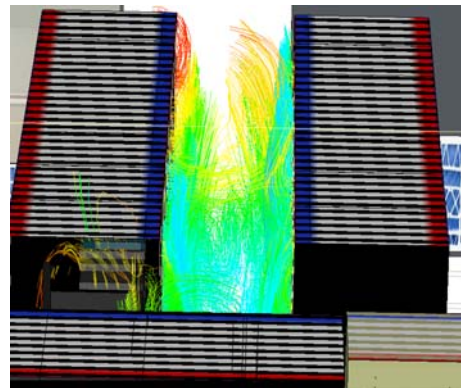
All of the new CRAC units installed in the existing solutions outlined above have fans operating slightly below their rated value. Increasing the fans to max output provides sufficient cooling for a 25% increase in heat for both solutions. Once the room load begins to expand beyond this initial 25% load increase, additional space and cooling will be needed to ensure all of the equipment is being properly cooled. The following images are when all of the previously discussed changes have been made including blank plates, rack orientation, and additional units added. Room loads here consist of 92.75 kW of equipment load and the same 2.11 kW of lighting load.

Figure 3.2.1 – Solution 1 with 25% Load Increase

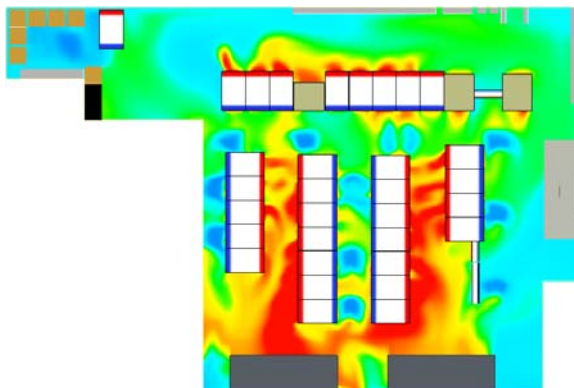
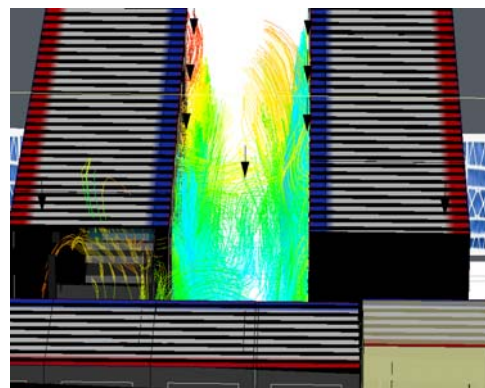
Figure 3.2.2 – Solution 2 with 25% Load Increase

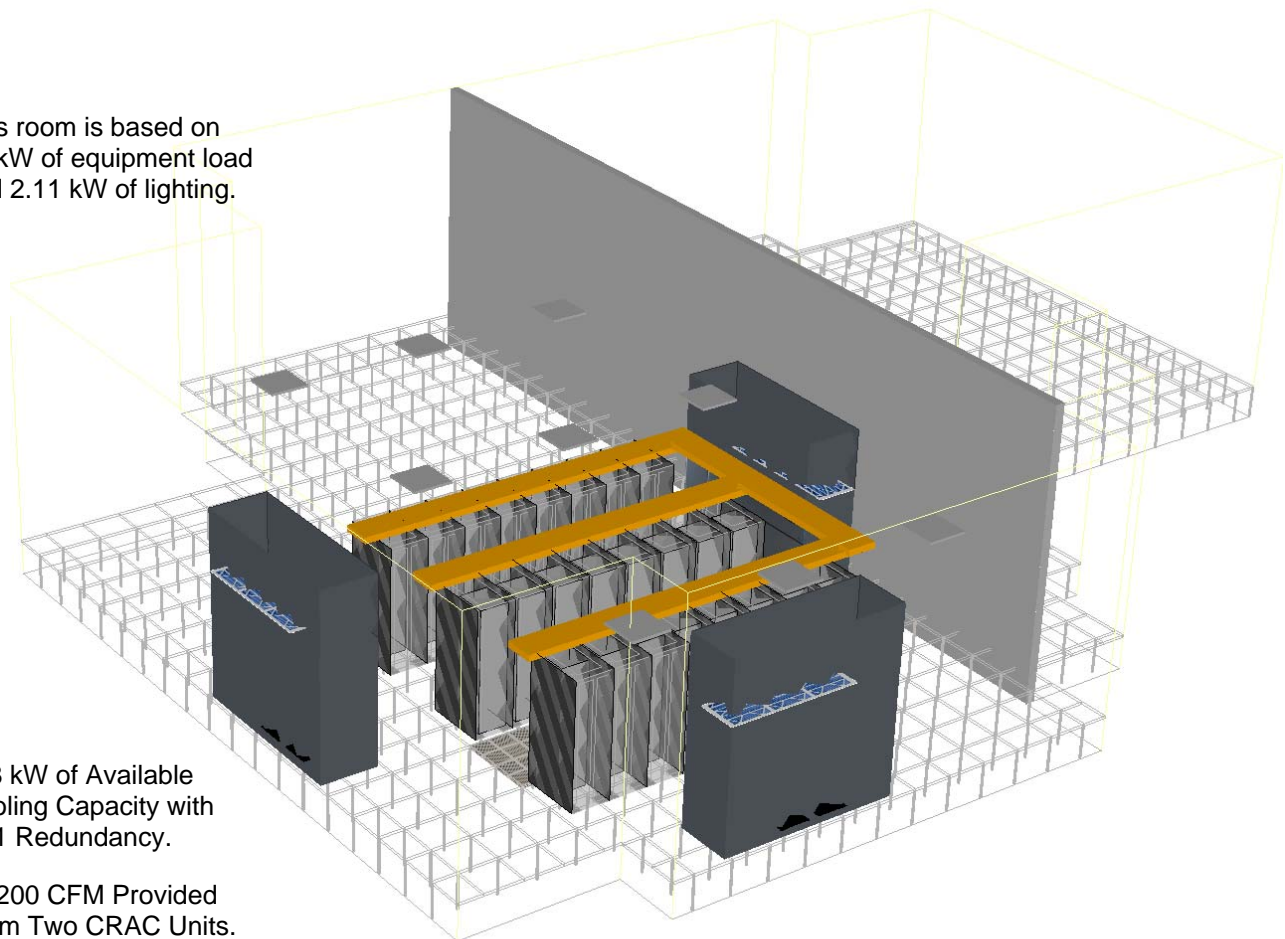
108 kW of Available  
Cooling Capacity with  
N+1 Redundancy.

19,200 CFM Provided  
From Two CRAC Units.

Figure 3.2.3 – Phase 1 Expansion - Isometric

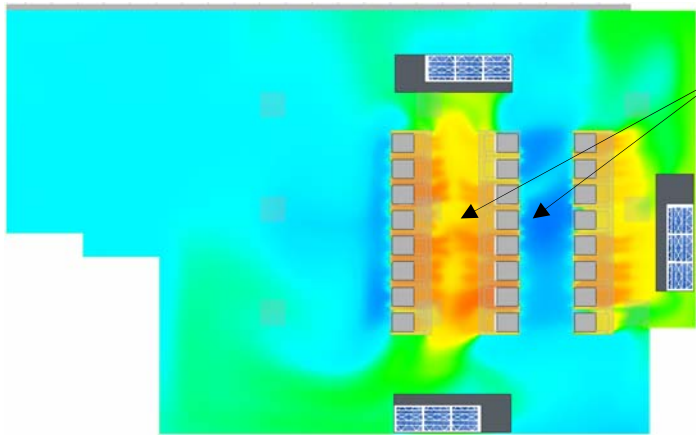
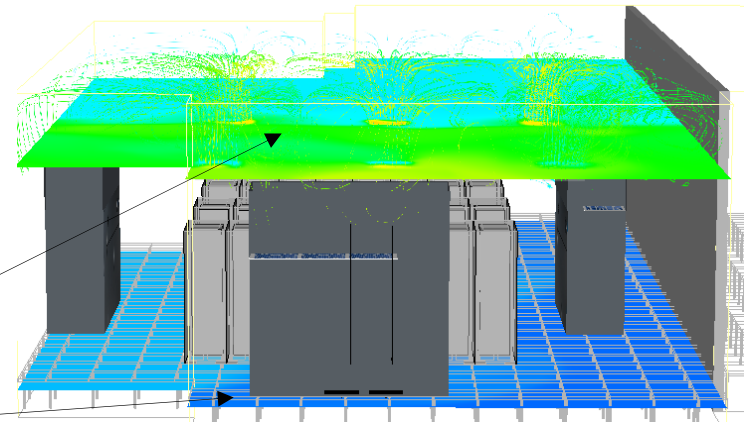
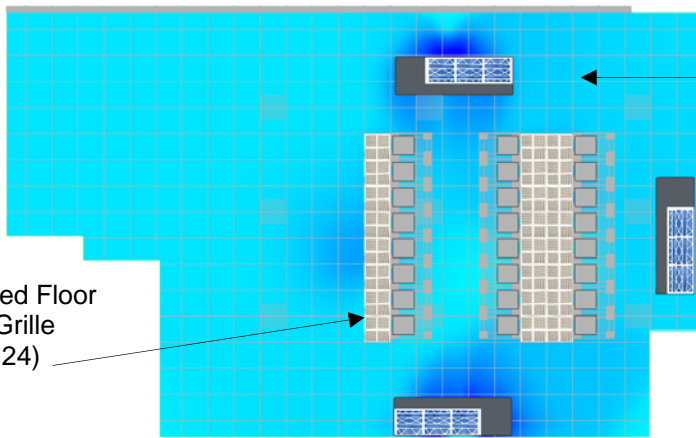
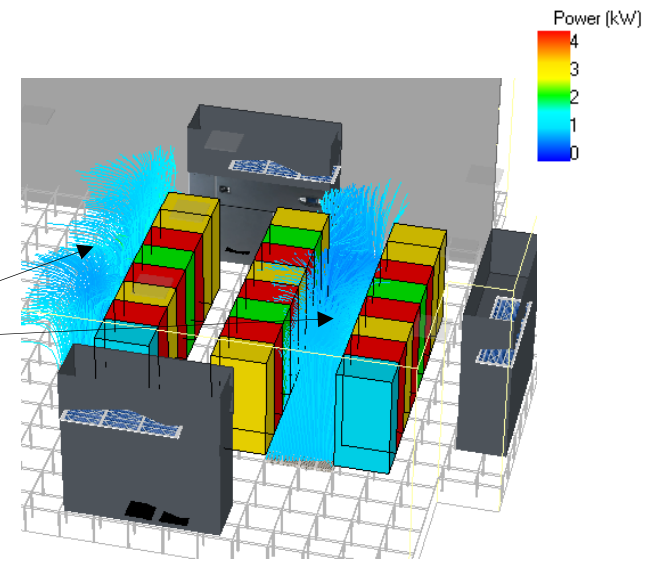
Figure 3.2.4 – Phase 1 Results

Excellent Isolation of Air Between Hot and Cold Aisles.

Consistent Under Floor Air Pressures Produces Good Air Flow at Floor Grilles.

Abundant Supply Air Flow for Server Inlets.
