# Emerson Network Power Data Center Assessment Report of Findings

Customer A

Data Center Assessment

1243 Happy Days Lane  
Somewhere, MN 55555

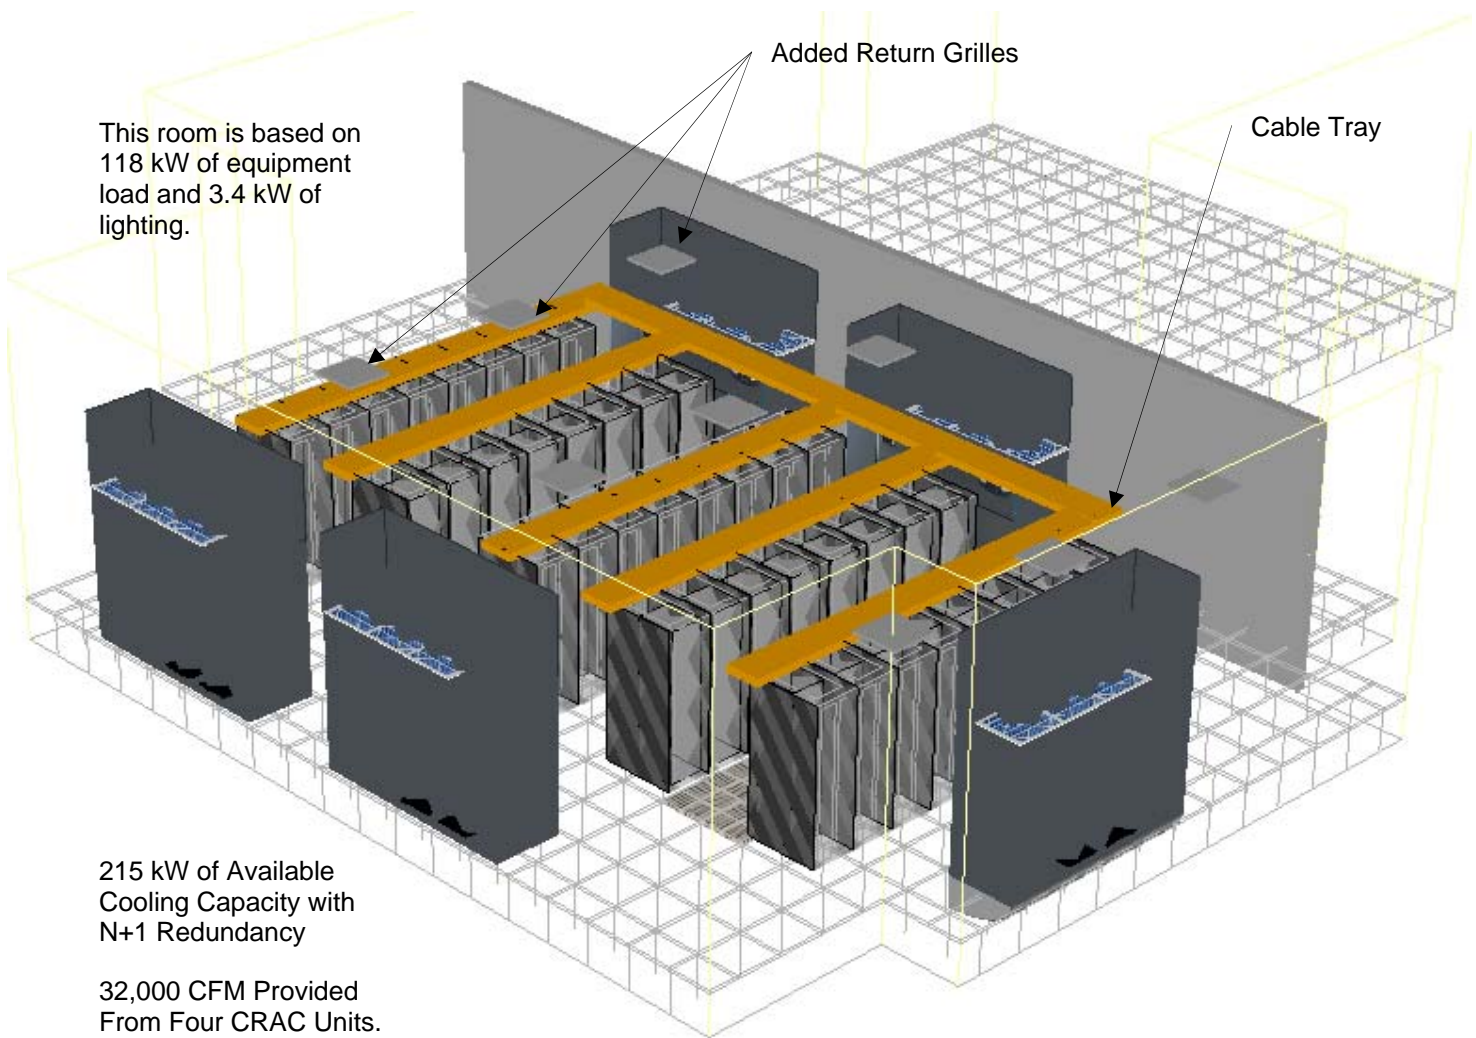
Figure 3.2.5 – Phase 2 Expansion - Isometric

1. Install (2) more 20 ton down flow CRAC units into space.
  - Place at end of future hot aisles (see plan).
  - Power on units as equipment is installed and demands additional airflow.
  - The floor mounted units should not have turning vanes installed on the supply grilles.
2. Add racks, servers and other equipment as needed
  - (16) additional 2'x2' perforated floor tiles with 56% open area and dampers needed
  - (3) additional 2'x4' egg crate ceiling return grilles needed (placed above hot aisle)
3. Begin the remodel of the old data center to match the layout of the current.
4. All CRAC units have return air plenum connecting the unit to the ceiling. Refrigerant Piping will extend up through the plenums to rooftop condensers.

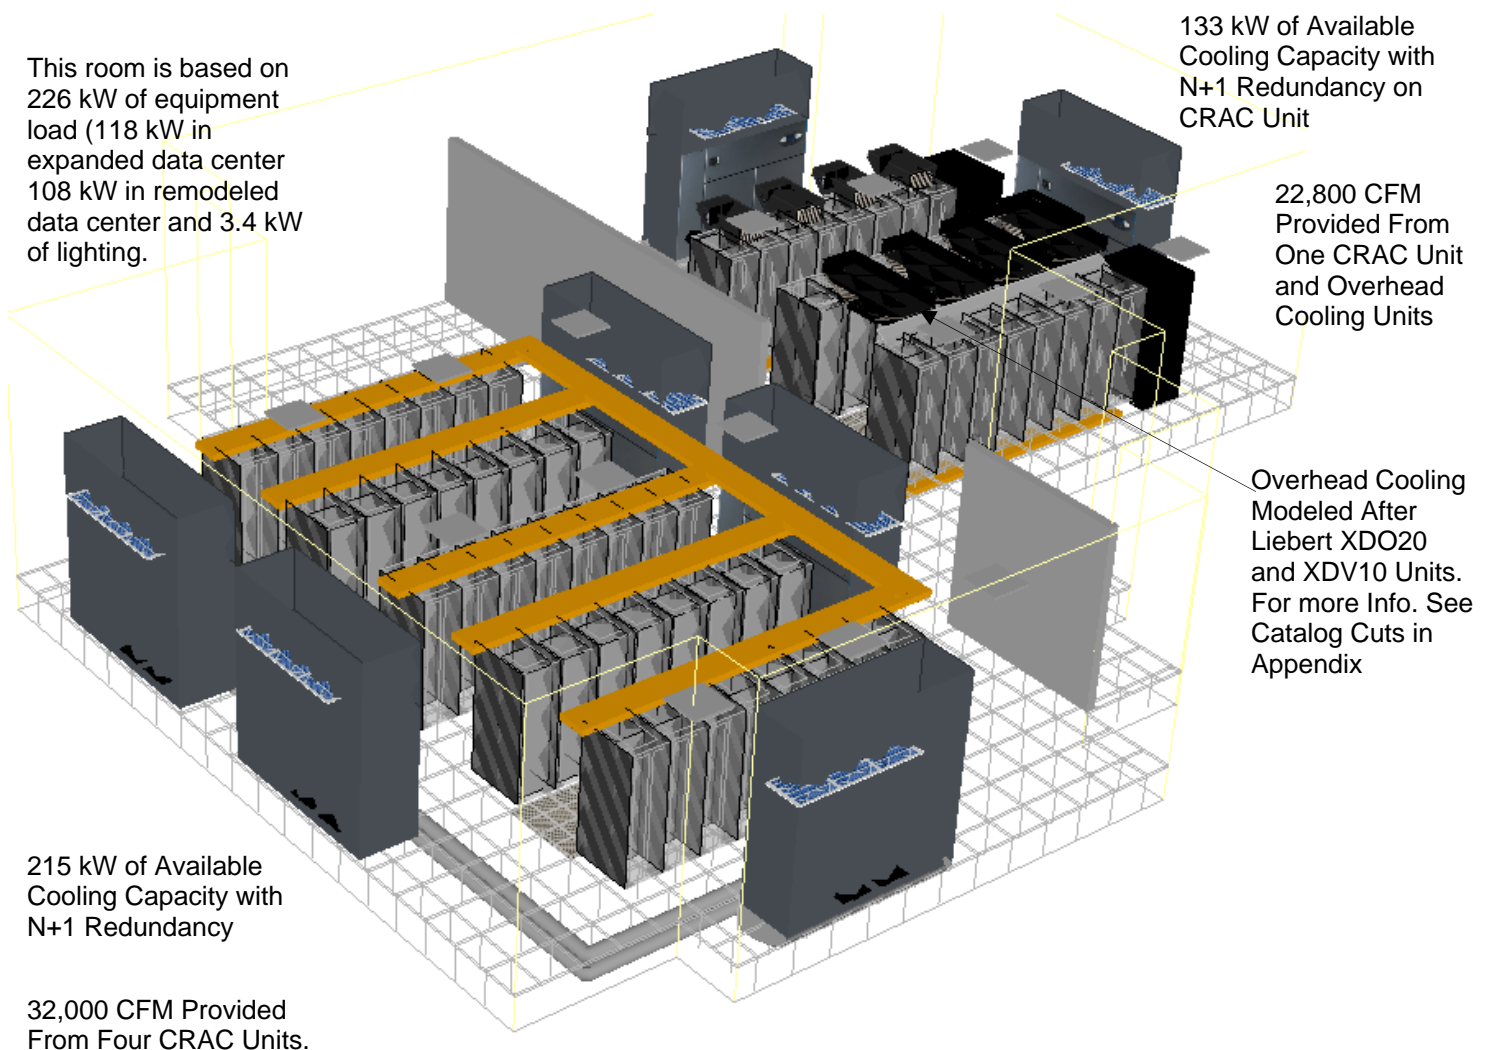
Figure 3.2.7 – Phase 3 Expansion - Isometric

- (6) additional 2'x4' egg crate ceiling return grilles needed in remodeled area hot aisles
5. All CRAC units have return air plenums connecting the unit to the ceiling. Refrigerant Piping will extend up through the plenums to rooftop condensers.
